NASA Technical Memorandum 100189

Analysis of Convair 990 Rejected-Takeoff Accident With Emphasis on Decision Making, Training, and Procedures

Byron E. Batthauer
Lewis Research Center
Cleveland, Ohio

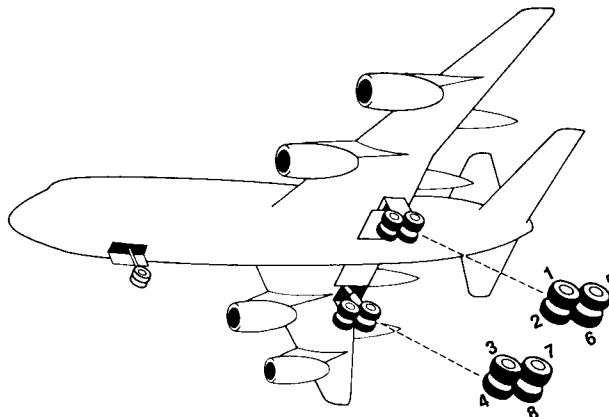
The flightcrew stated that everything was normal in the cockpit during the first part of the takeoff roll. However, the occupants of the cabin and several witnesses outside the aircraft noted abnormalities. A technician, watching a television monitor linked to a camera focused on tire 3 (fig. 1), noticed deformation of the tire early in the takeoff roll before the tire blew out. Another technician occupying a right-side cabin seat aft of the wing had a fleeting perception of a "black object flying over the wing." An outside witness made a similar comment. Other witnesses, who were positioned about 2 miles from the aircraft, noticed white smoke coming from the aircraft underside early in the takeoff roll. There was no indication of these abnormalities in the cockpit, nor did the cabin occupants relay their observations to the flightcrew.

Figure 1. - Positions of tire and wheel assemblies on CV-990 main landing gear.

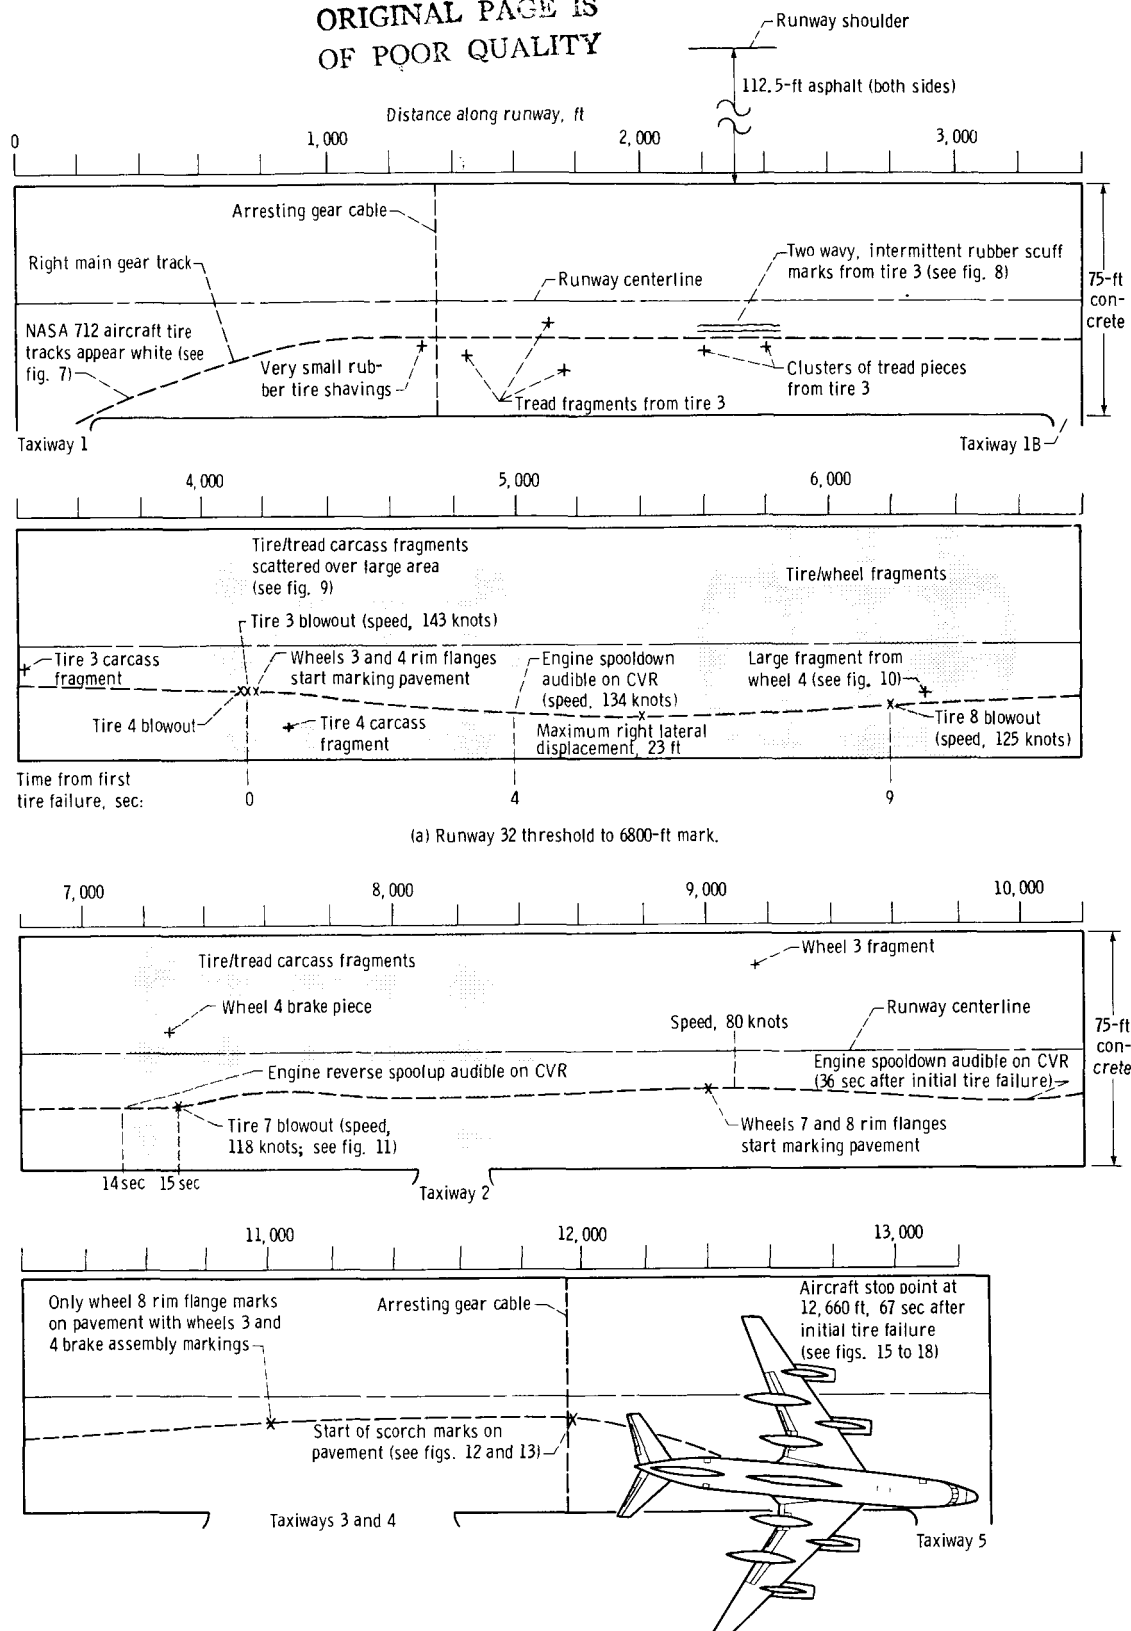
To assist the Accident Board in analyzing the sequence of the aircraft accident events, a runway event reconstruction was diagrammed (fig. 2). This was accomplished by identifying the debris and its location on the runway, along with marks made on the runway surface primarily by the tire and wheel assemblies of the right main landing gear. From this and other factual data, the following accident sequence analysis was made.

Figure 2. - Reconstruction of NASA 712 accident. Total runway width, 300 ft with 75-ft concrete surface in center and 112.5-ft asphalt on both sides.

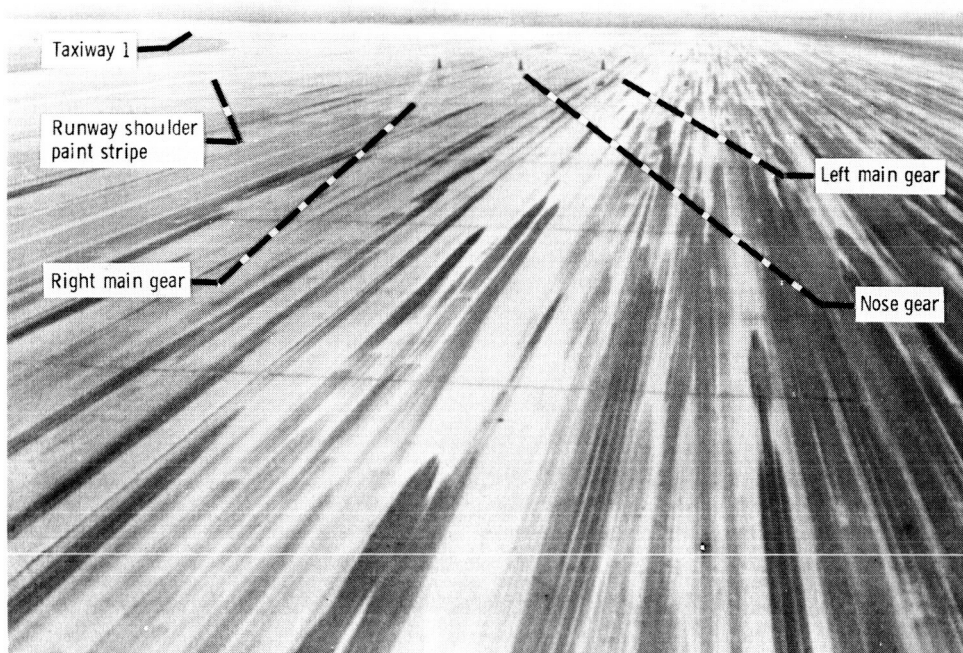
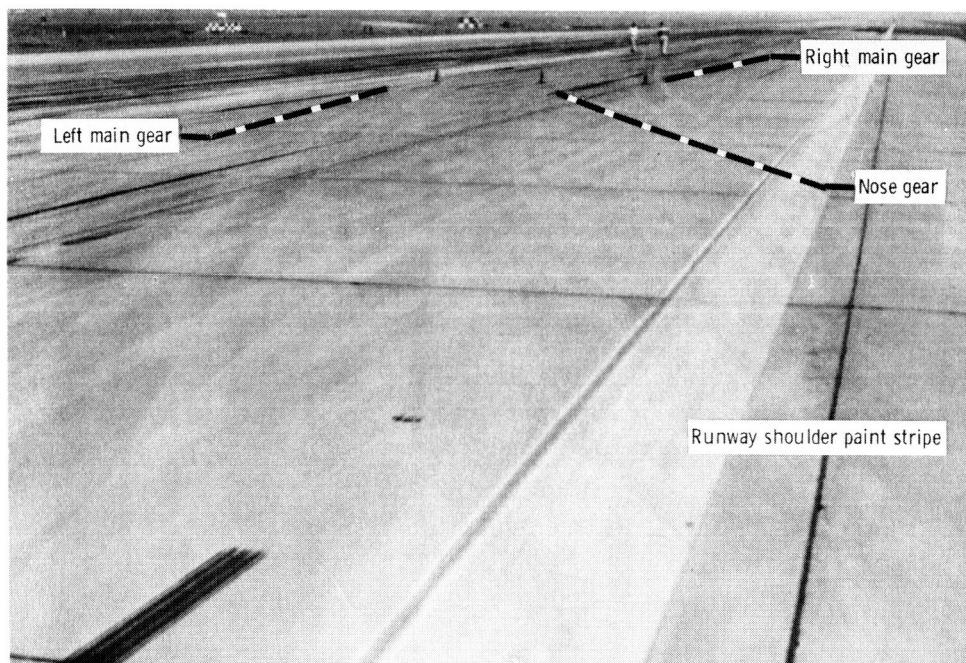
As the aircraft taxied onto runway 32, it left a distinctive white track (fig. 3). The aircraft tires scrubbed black jet engine exhaust deposits off the concrete runway surface during the turn onto the runway. These white tire marks faded away as the aircraft entered the moderate-to-heavy rubber-contaminated area near the runway centerline at about 700 feet.² The width of the individual tire tread was uniform, showing no evidence of lost inflation pressure or other tire abnormality. Light or even moderate brake drag probably would not be detected on the runway or taxiway surface, but subsequent heat effects would have occurred in the tire body. The first tire rubber shards were found at about 1,400 feet on the right side of the centerline near the arresting gear cable. At 2,200 feet and about 11 feet right of the centerline, fresh squiggly rubber marks were found on the rubber-coated concrete surface in line with the estimated position of tires 3 and 7 (fig. 1). These wavy intermittent rubber marks, visible for about 400 feet (fig. 4), were later associated with tire 3 by tread debris found nearby. All of the tire fragments collected on the runway between 1,300 and 4,000 feet were later identified with tire 3. The tire 3 retread cap (fig. 5), most of which was recovered, showed no heat effects. Inspection of the wheel bearings on the right main landing gear, with particular emphasis on bearings 3 and 4, revealed no abnormalities. An inspection of the brakes, although not conclusive because of fire damage, showed no evidence of dragging. Therefore it was concluded that the main gear tires were properly inflated and that the brake systems were normal during the initial takeoff acceleration roll.

(a) On runway 32 looking back toward taxiway 1.

(b) Near runway shoulder at taxiway 1 looking toward runway 32.

Figure 3. - Suspected white tire scrub marks produced during turn onto runway 32 at taxiway 1.

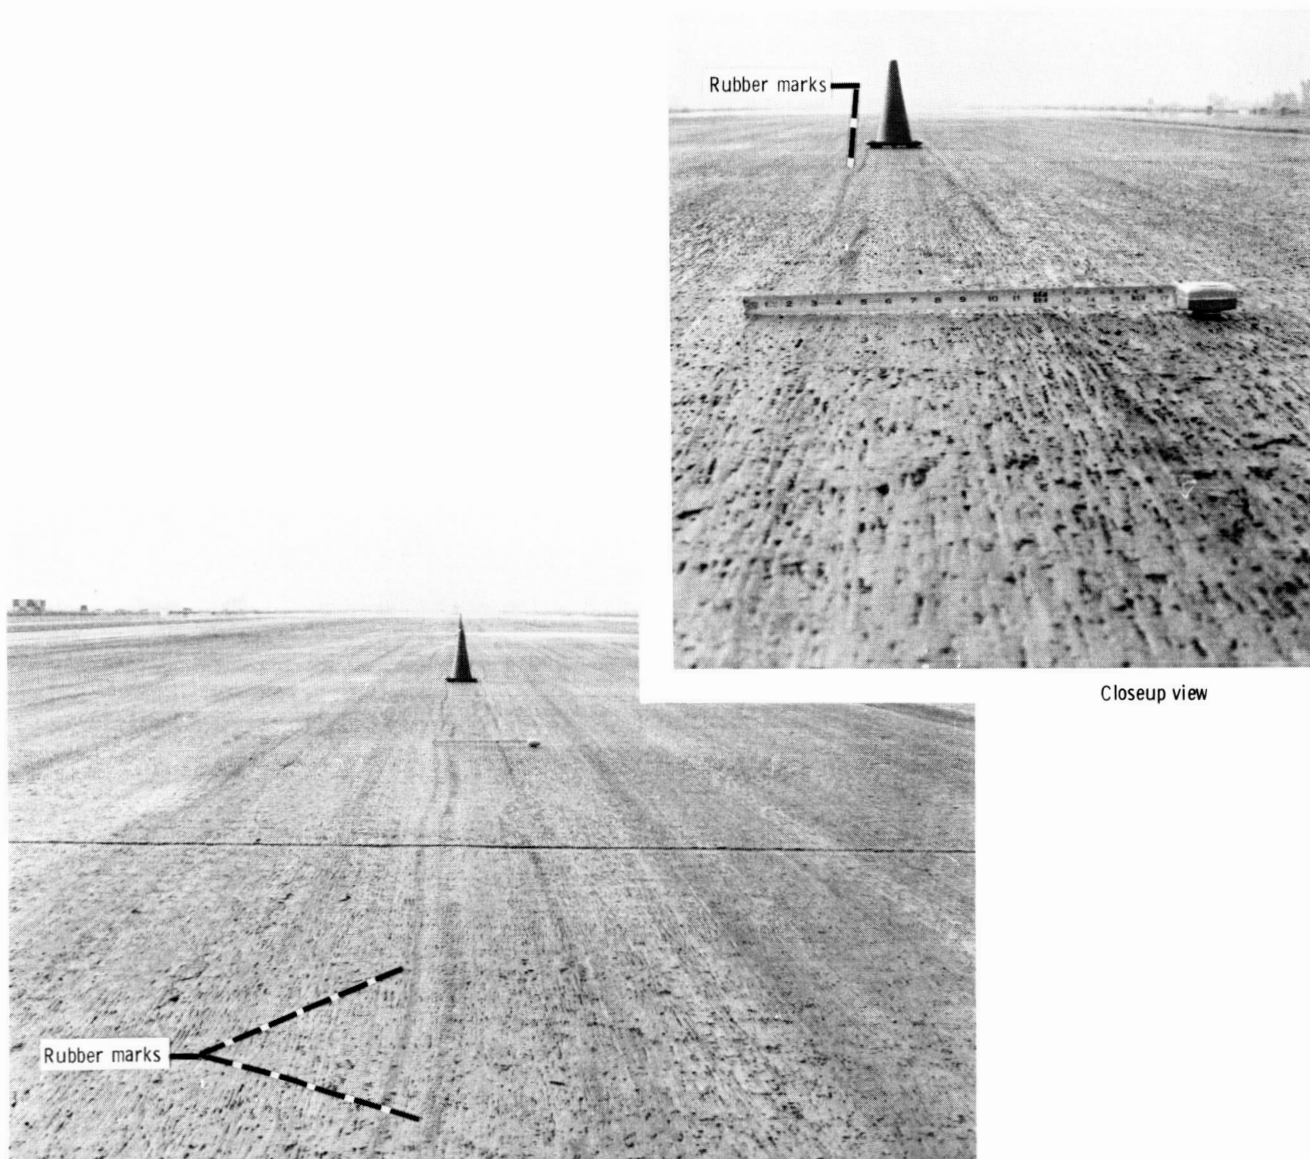
The analysis of tire and wheel marks on the runway indicated that the failure sequence began when the tread from the tire 3 started coming apart at about 1,400 feet. The failing tire 3 caused tire 4 (both on the same axle) to run in an overloaded condition. This continued until the 4,125-foot mark, when tire 4 blew, followed 0.05 second later by the blowout of the tire 3 carcass at 4,138 feet. The postaccident examination of the tire fragments indicated that extreme heat had built up in tire 4, contributing to its failure. Fragments of tires 3 and 4 were scattered over a large portion of the runway surface between 4,000 and 5,200 feet. The drag resulting from the tire failures caused the aircraft to swerve slightly to the right. Marks on the runway indicated that the swerve began within 300 feet (less than 2 seconds) of the first two tire blowouts. There were no visible indications of left main gear wheel braking to correct for this swerve and, in fact, the pilot stated that he was "going to stay off the brakes." The actions taken by the pilot, after the first tire blowouts, were to close the throttles (the CVR indicated that the throttles were closed within 4 seconds of these blowouts), to deploy the spoilers, and to correct for a slight right swerve. There was no runway evidence of wheel braking from either the fully operational left main gear or the failing right main gear during the entire rollout.

Figure 4. - Tire 3 rubber marks found on surface 2, 200 ft from threshold of runway 32.

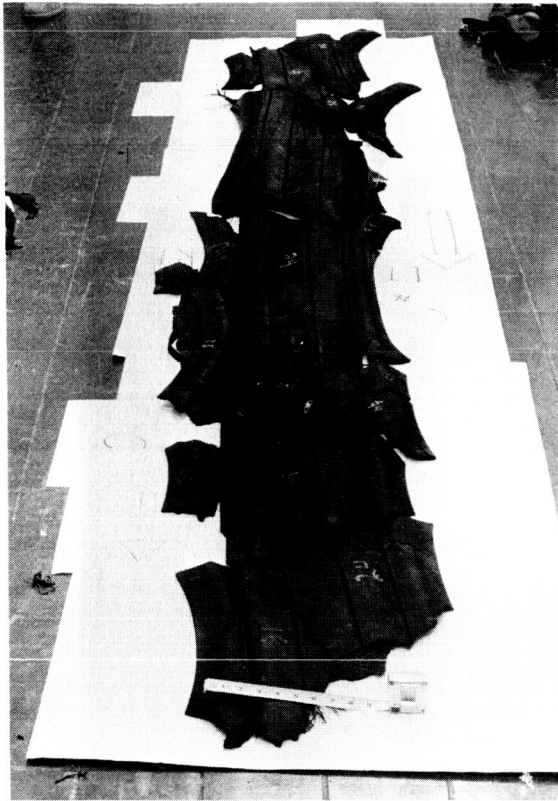
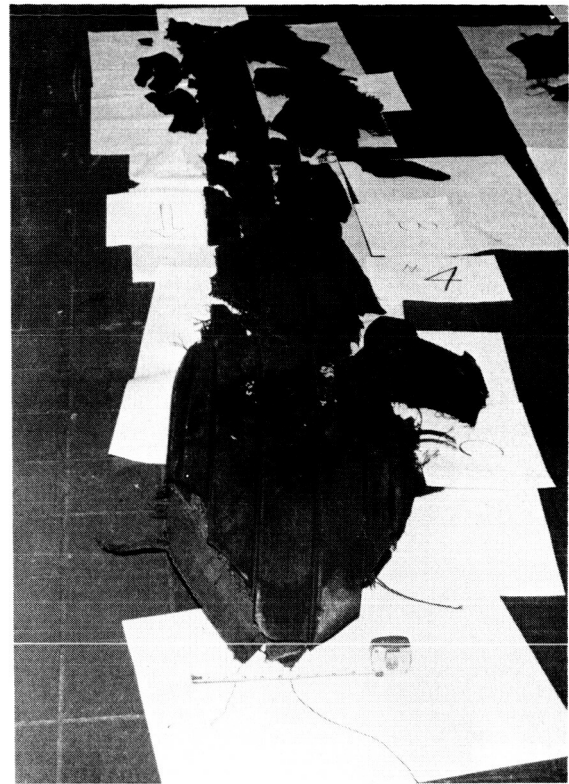
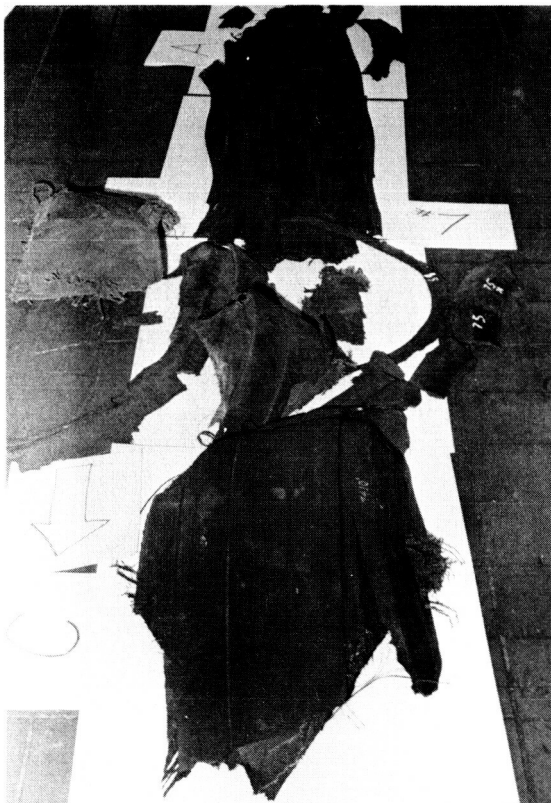
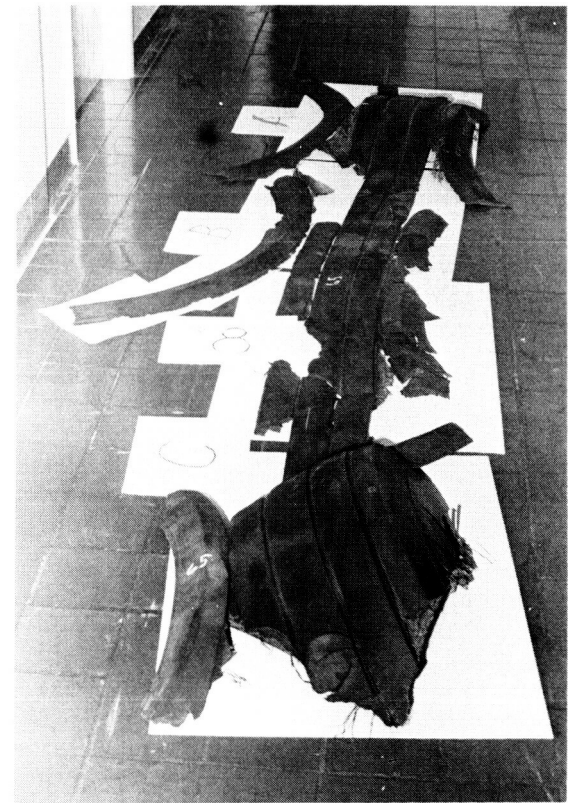
(a) Tire 3 - left front.

(b) Tire 4 - right front.

(c) Tire 7 - left rear.

(d) Tire 8 - right rear.

Figure 5. - Assembled fragments of right main gear tires from NASA 712, found on runway 32 at March Air Force Base, California.

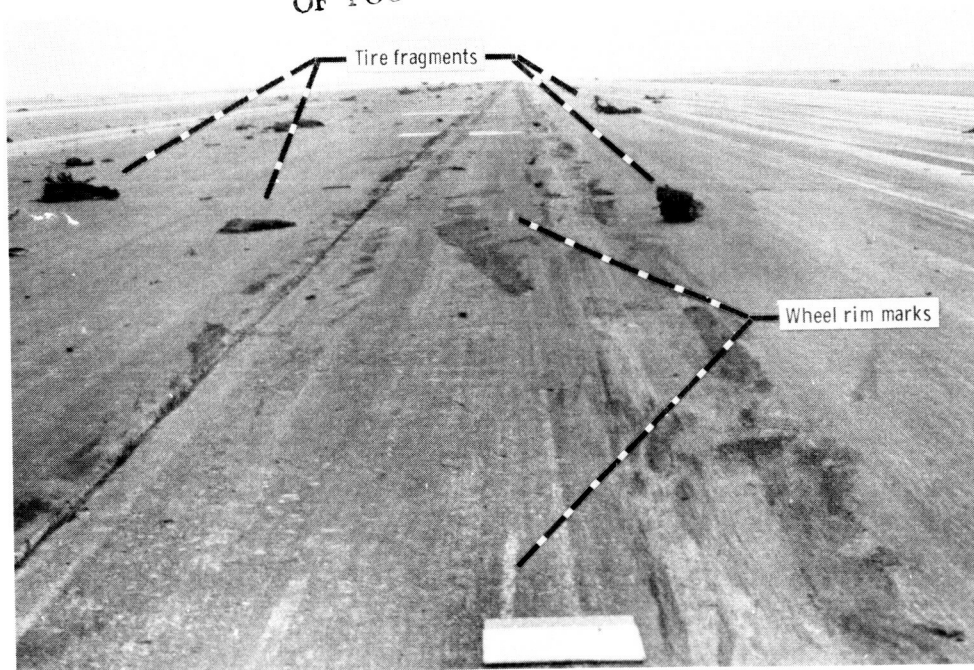
With the failure of tires 3 and 4 on the right truck, visible score marks (fig. 6), starting at about 4,175 feet, showed where the number 3 and 4 frangible aluminum wheels contacted the runway. The right side of the aircraft was now supported by tires 7 and 8 and wheel rims 3 and 4. The aircraft began riding intermittently on wheel rims 3 and 4 from the 4,175-foot point, since most of the rubber of tires 3 and 4 (except for the bead bundles) quickly abraded. Wheel fragments from wheels 3 and 4 were found on the runway starting at about 5,600 feet, the point at which the rims started breaking up, scattering fragments in all directions. A fragment from wheel 4 is shown in figure 7. These fragments may have contributed to the failure of the two rear tires. Rubber marks on the runway surface at 6,190 feet indicated where tire 8 blew out. From CVR information this occurred 9 seconds after tire 4 blew out. The flightcrew perceived this as the second tire failure. Scuff marks on the runway surface at 7,300 feet (fig. 8) indicated where tire 7 blew out, and the sound was recorded on the CVR. However, the flightcrew stated that they did not hear the blowout as it was masked by the sounds of engine spoolup as reverse thrust was being applied 12 seconds after the "abort" callout. A large number of tire rubber and wheel fragments were found scattered over the runway from 7,100 to 8,400 feet (fig. 9).

Figure 6. - Wheel flange rim marks and debris from tires 3 and 4 at approximately 4,188 ft from runway 32 threshold.

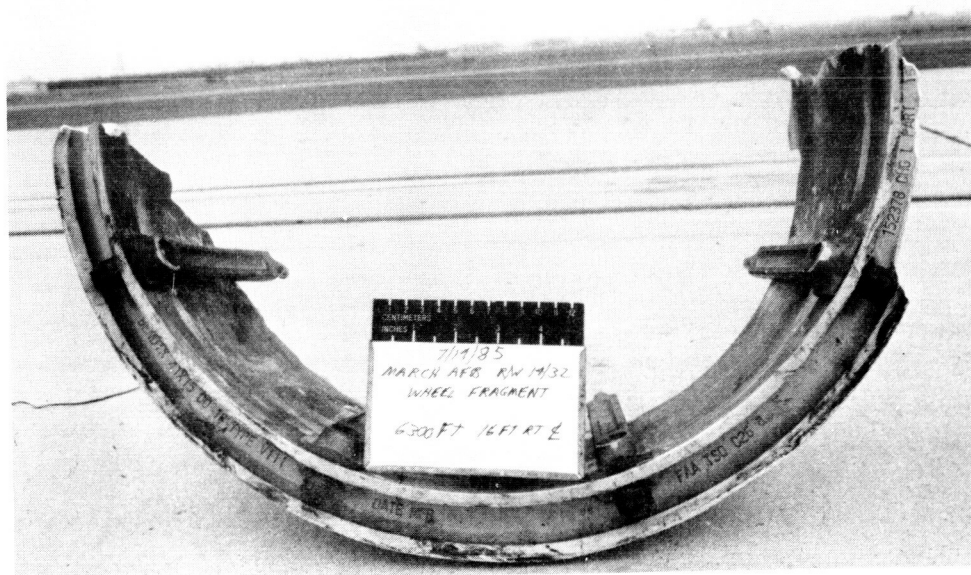
Figure 7. - Fragment of wheel 4 found 6,300 ft from runway 32 threshold.

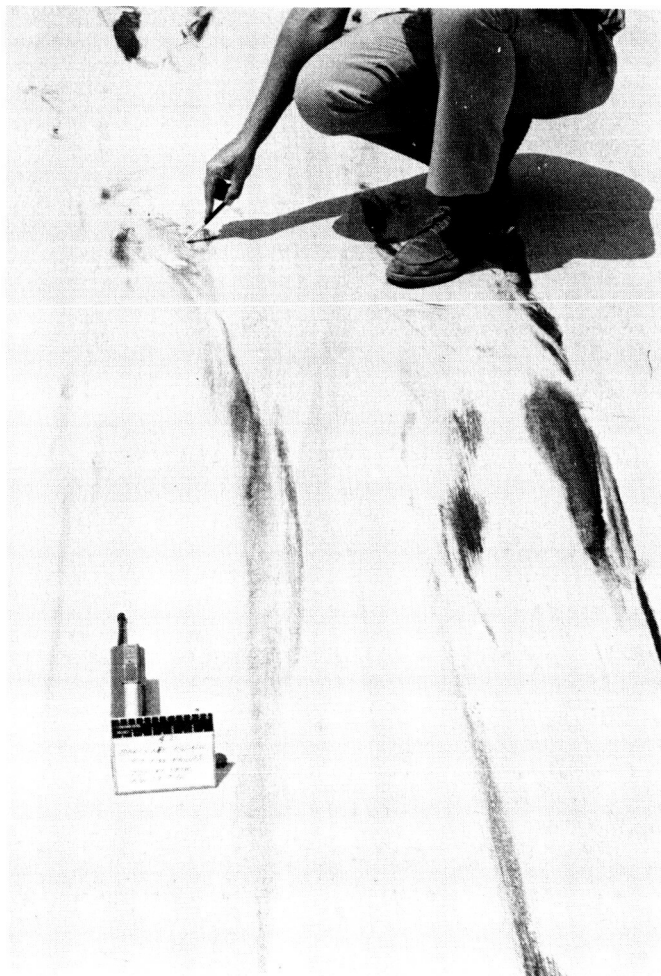
Figure 8. - Runway surface rubber marks from blowout of tire 7.

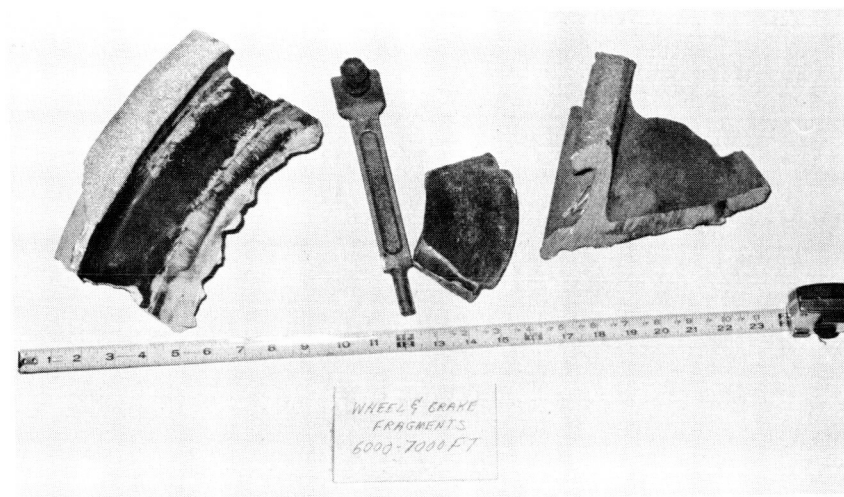
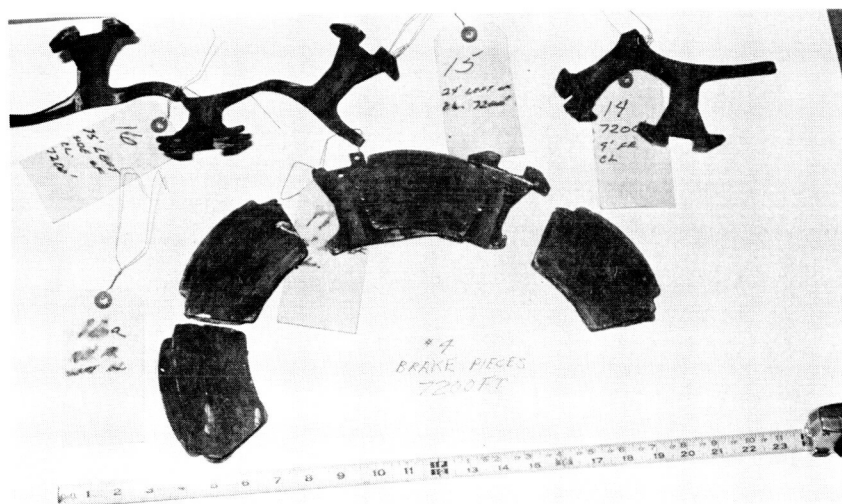
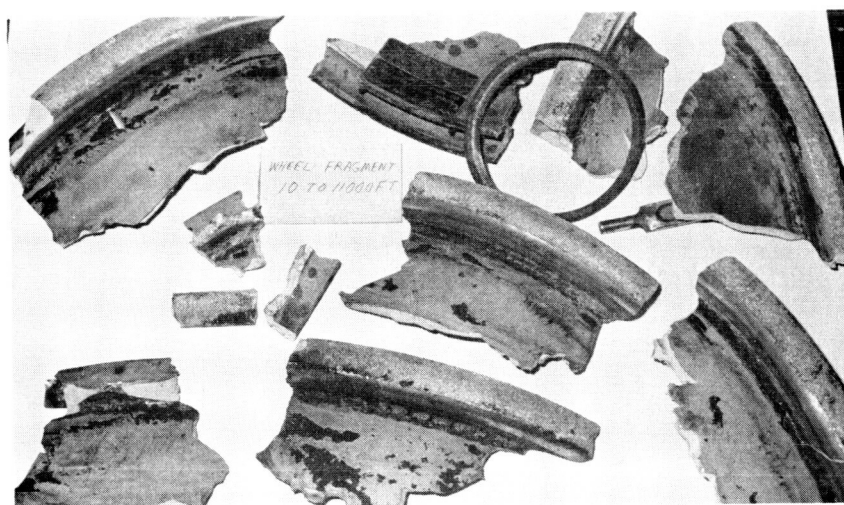
(a) Found between 6,000 and 7,000 ft down runway 32.

(b) Found nearly 7,200 ft down runway 32.

(c) Found between 10,000 and 11,000 ft down runway 32.

Figure 9. - Some additional fragments of right main gear wheel/brake assembly found at various locations on runway.

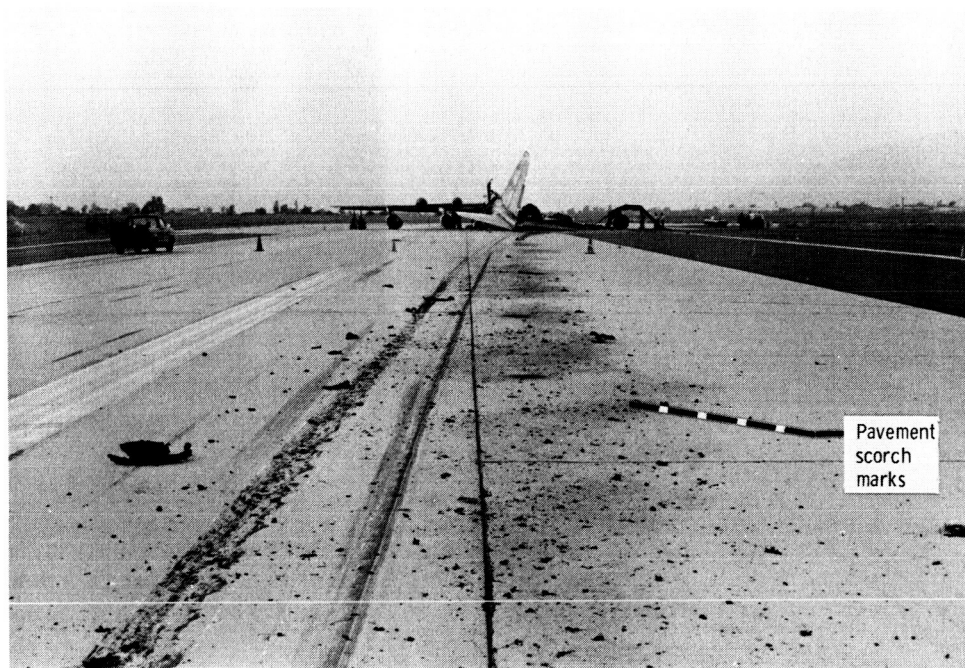
From witness testimony it is suspected that the wing was punctured after failure of the number 3 and 4 rim and wheel assemblies, somewhere between 6,000 and 7,000 feet from the takeoff end of the runway. Wheel scuff marks on the runway surface at 8,000 feet indicated that wheels 3 and 4 were worn down to the hub (wide marks) but that wheels 7 and 8 were still rolling on the rims (two narrow marks for each wheel). The scuffing on the runway of the tire remnants and bead bundles and the failure of tires 7 and 8 probably caused an almost continuous trail of white smoke to be emitted from the underside of the aircraft. However, it was not until after 7,000 feet that outside witnesses described intermittent flashes of fire around the right main gear. Inside witnesses saw flames coming from under the right wing flaps at 10,000 feet and passed this information to the flightcrew. The first evidence of fire on the runway - scorched, discolored concrete surface - was at 11,950 feet. The marks were in line with the tracks of the right main gear wheels. The scorched surface marks persisted down the runway to the aircraft stop point at 12,660 feet

Figure 10. - Runway surface scorch marks and tire rubber debris from right main gear at about 11,950 ft down runway 32.

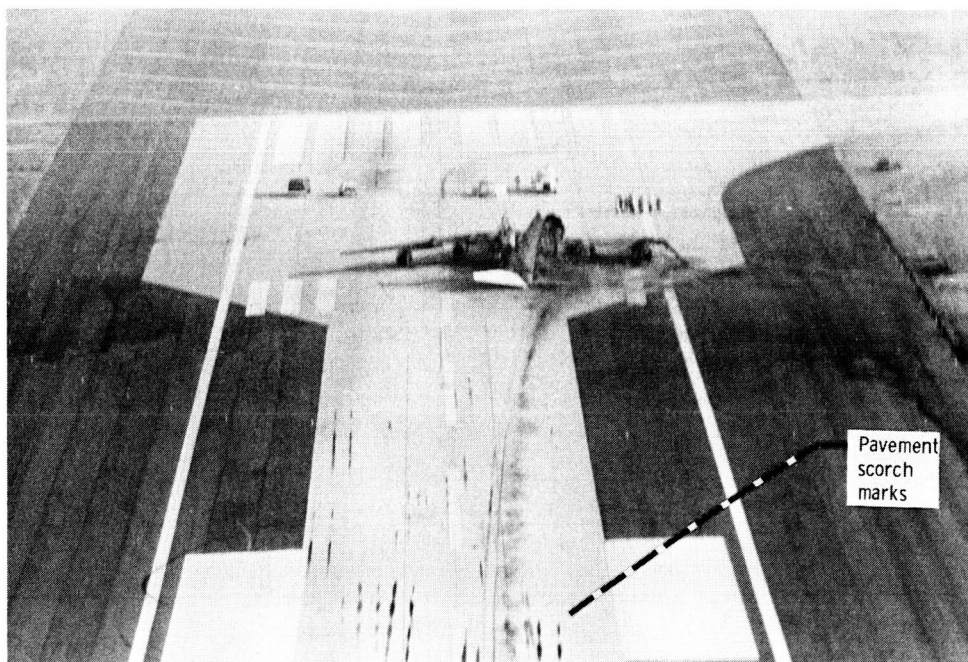
Figure 11. - Aerial view of fire-damaged NASA 712 at stop point, 12,660 ft down runway 32.

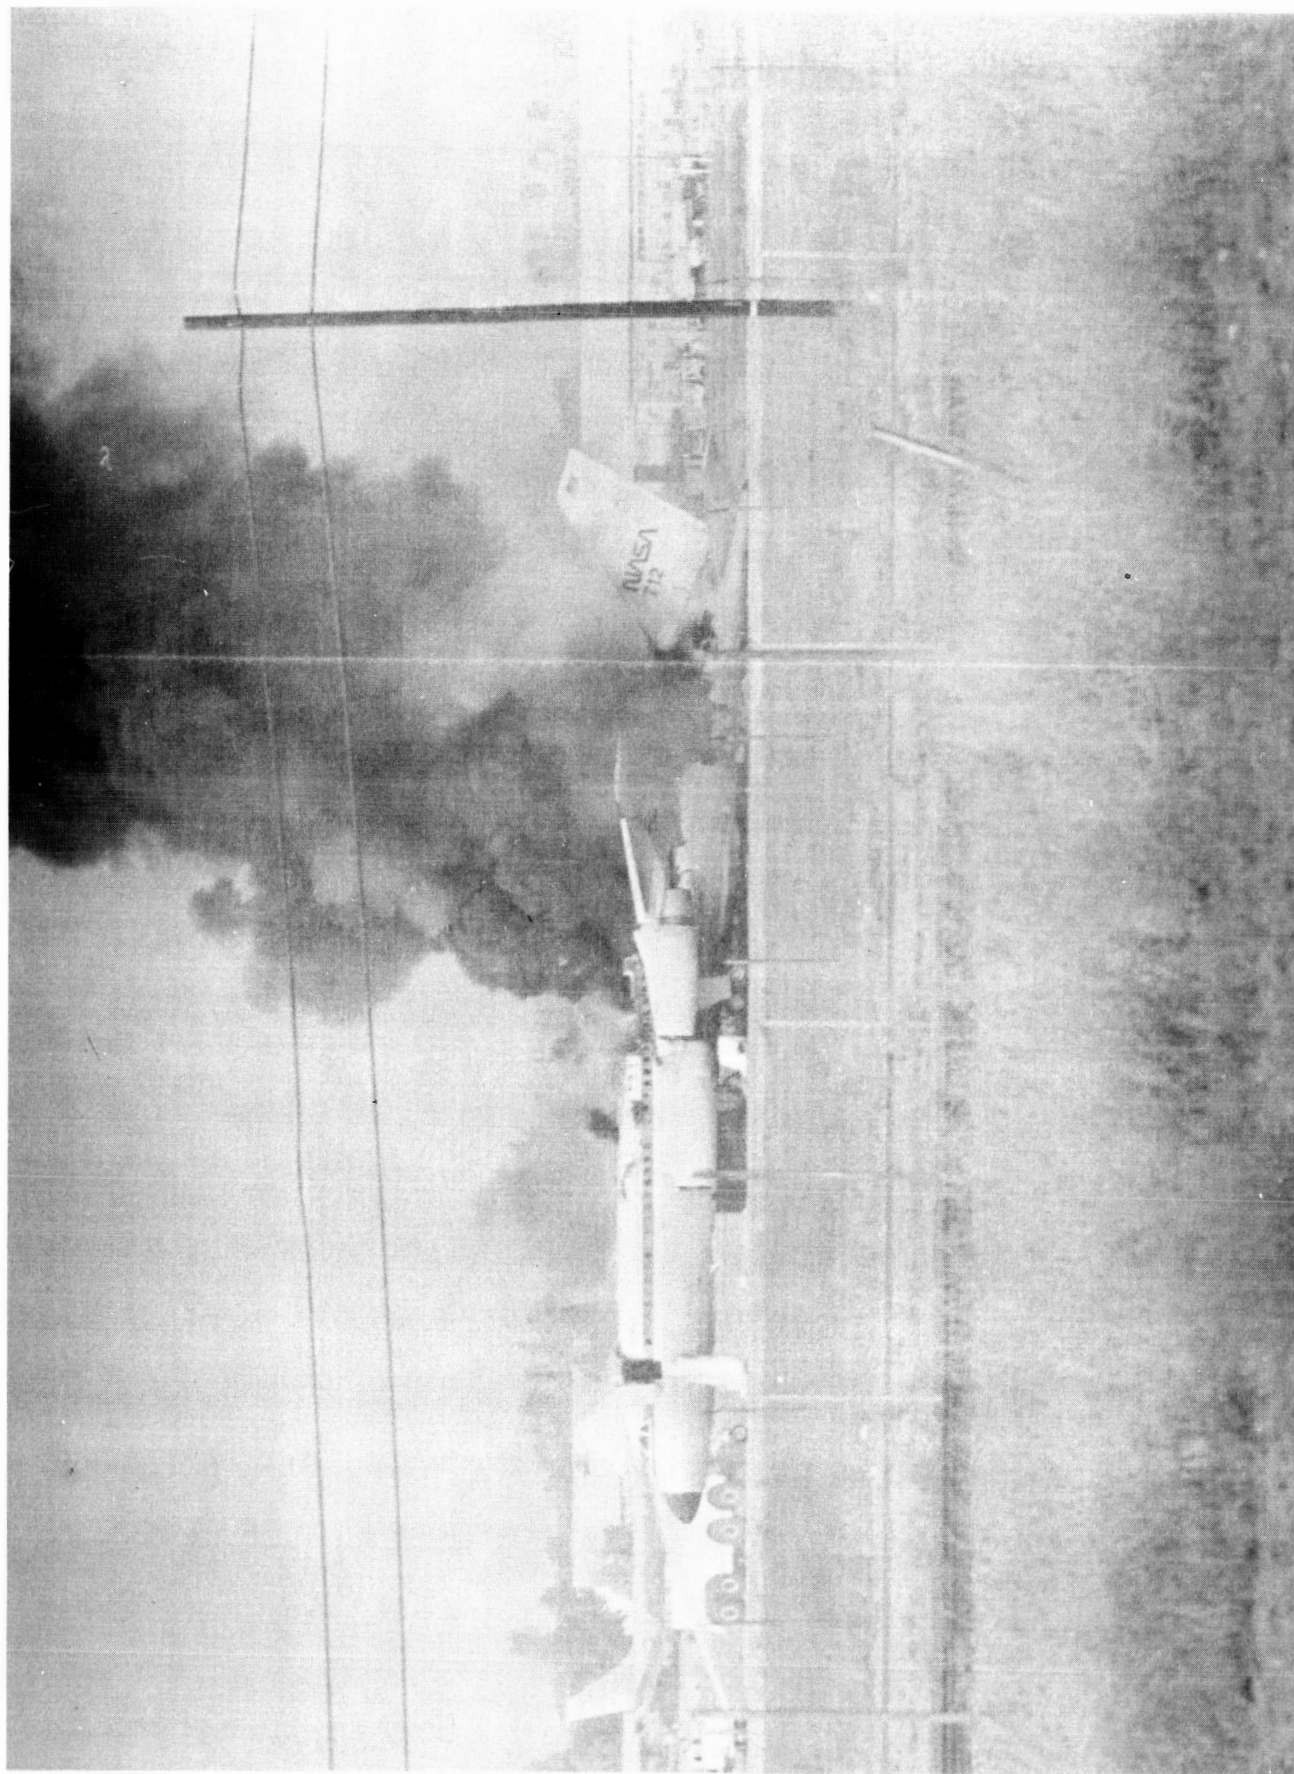
(figs. 10 and 11). The aircraft was immediately evacuated after it was brought to a stop. Shortly thereafter the aircraft was engulfed in flames (figs. 12 and 13). The aircraft wreckage on the runway was photographed from a helicopter (fig. 14) and at various ground locations (figs. 15 and 16).

Figure 12. - NASA 712 on fire at end of runway 32.

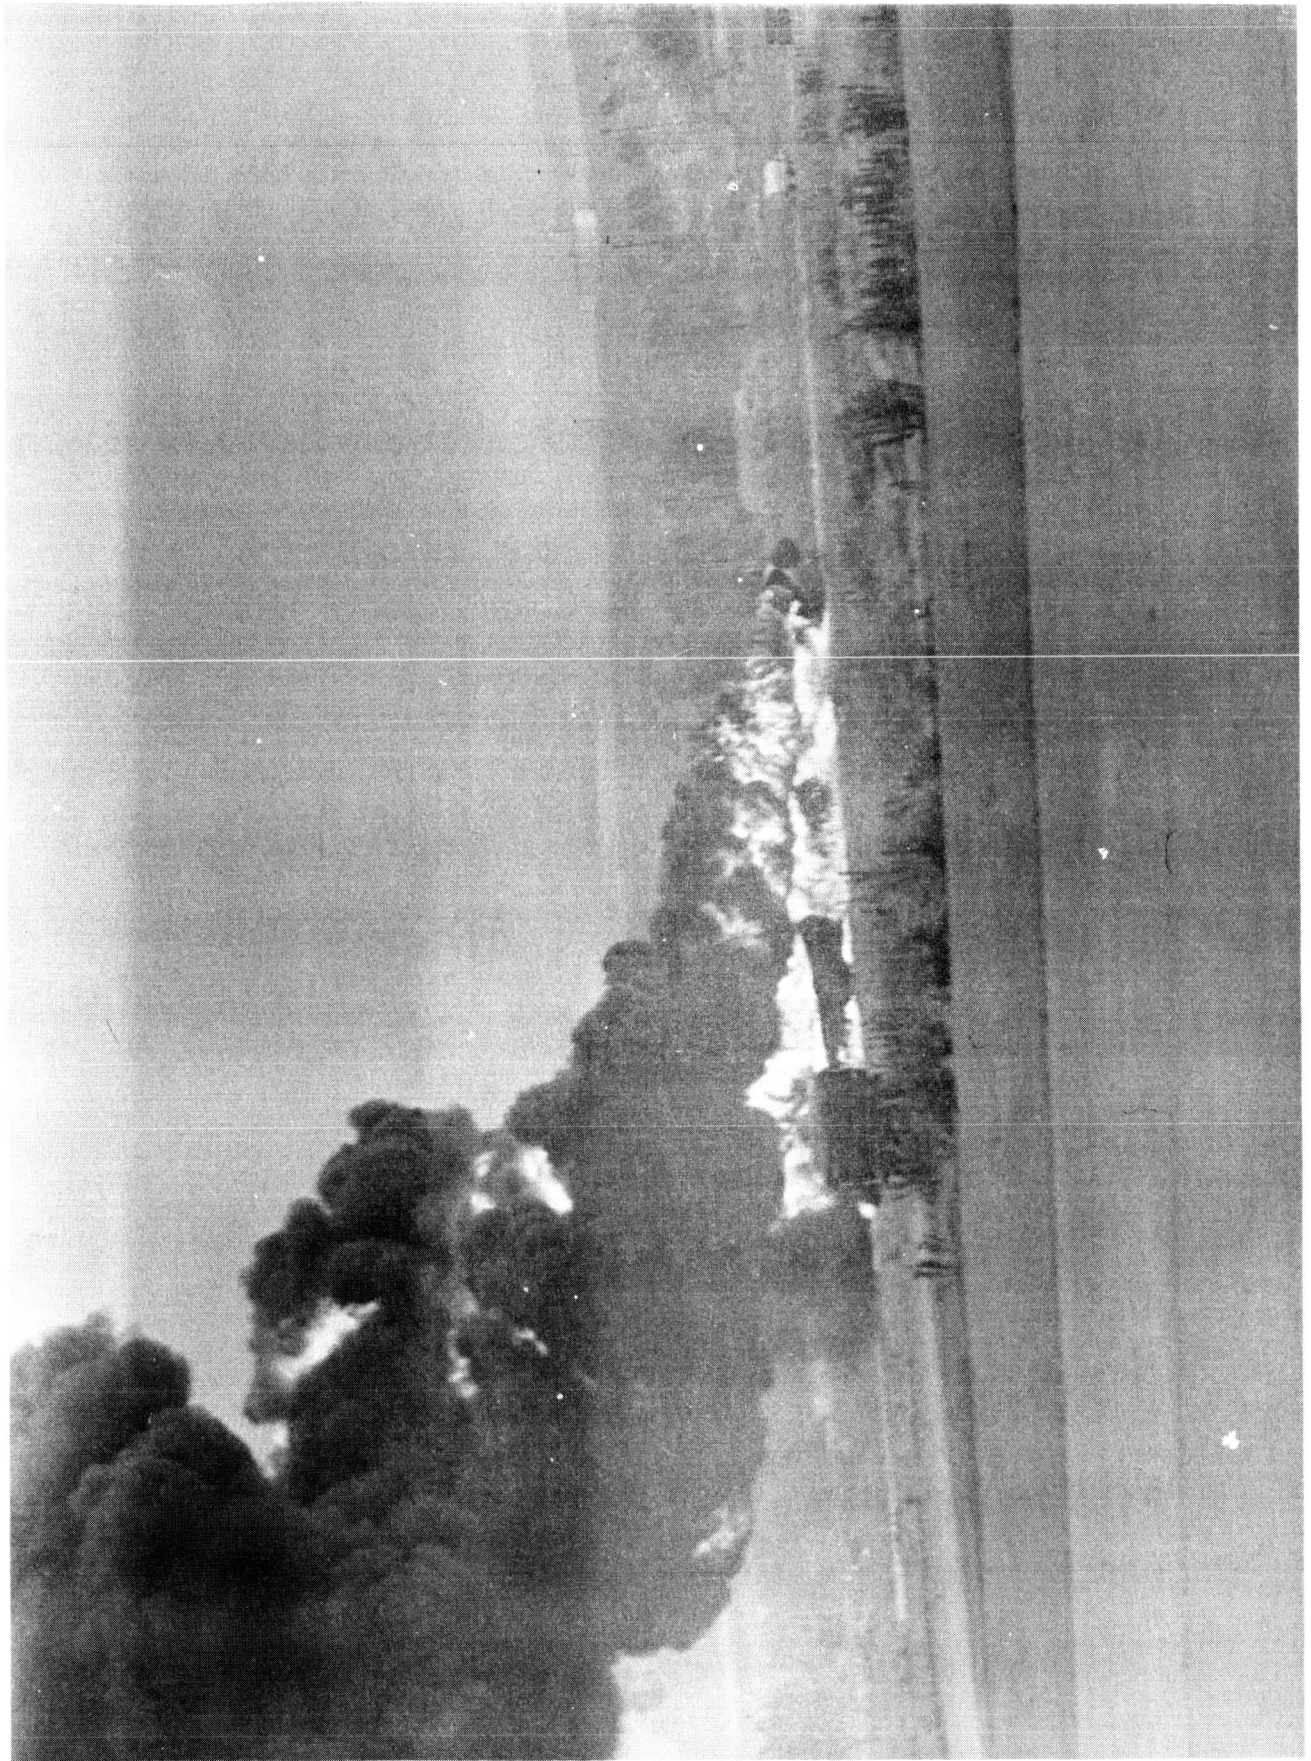
Figure 13. - NASA 712 engulfed in flames.

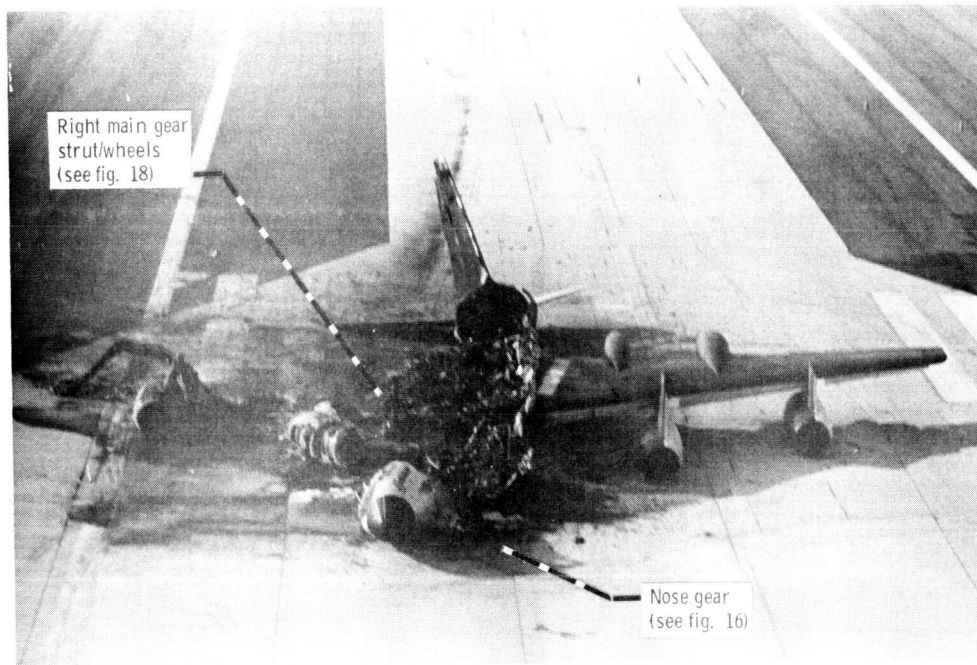
Figure 14. - Aerial view of fire-damaged NASA 712 taken at front of wreckage.

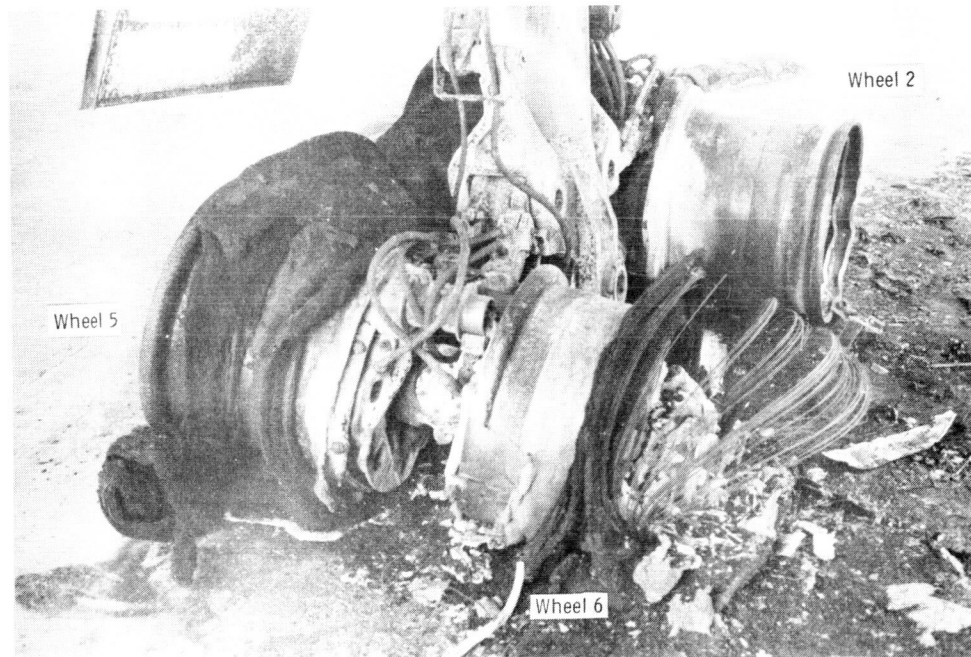
Figure 15. - Closeup view of left main gear wheels.

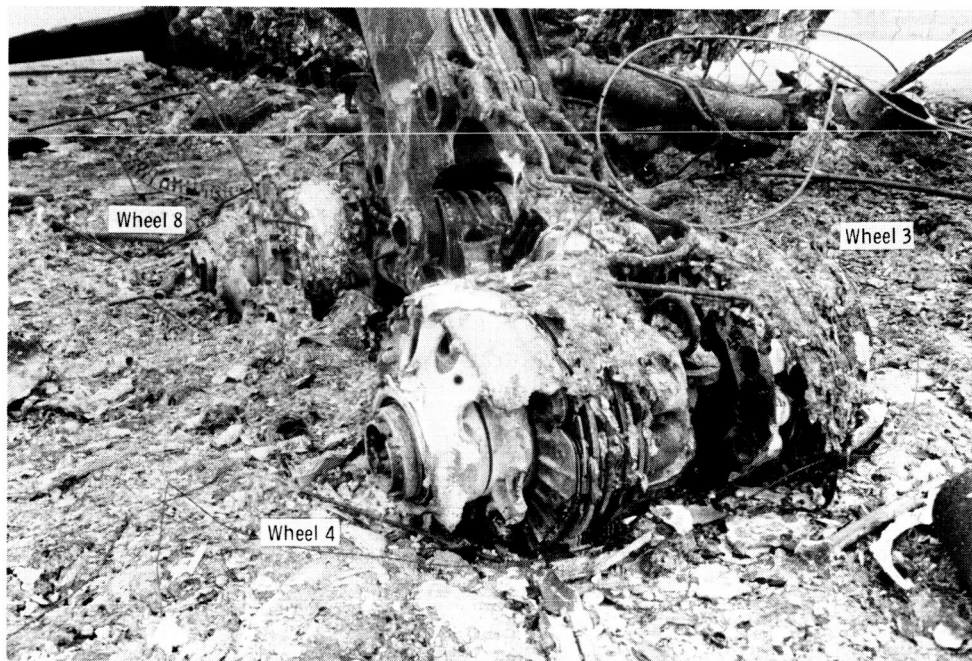
Figure 16. - Closeup view of right main gear wheels after fire.
